Washington State
School Seismic Safety Assessments Project

HOQUIAM FIRE DEPARTMENT 8TH STREET STATION City of Hoquiam

SEISMIC UPGRADES CONCEPT DESIGN REPORT

June 2021

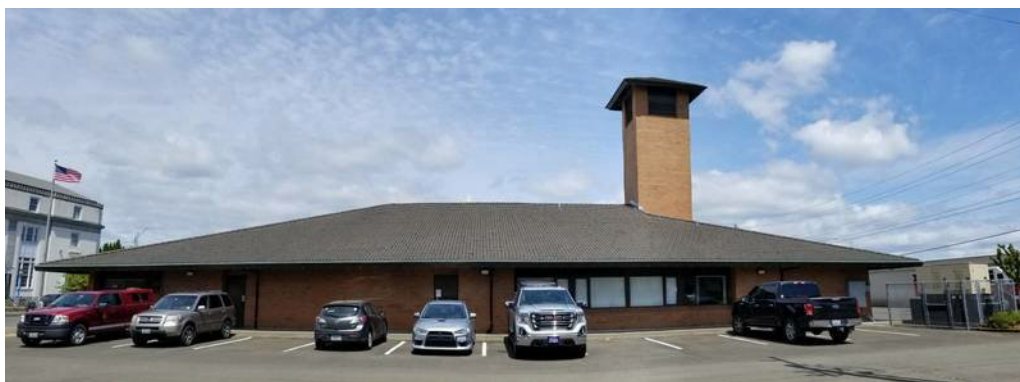
Figure 1-1. Southwest facade, which is the administrative side of the facility

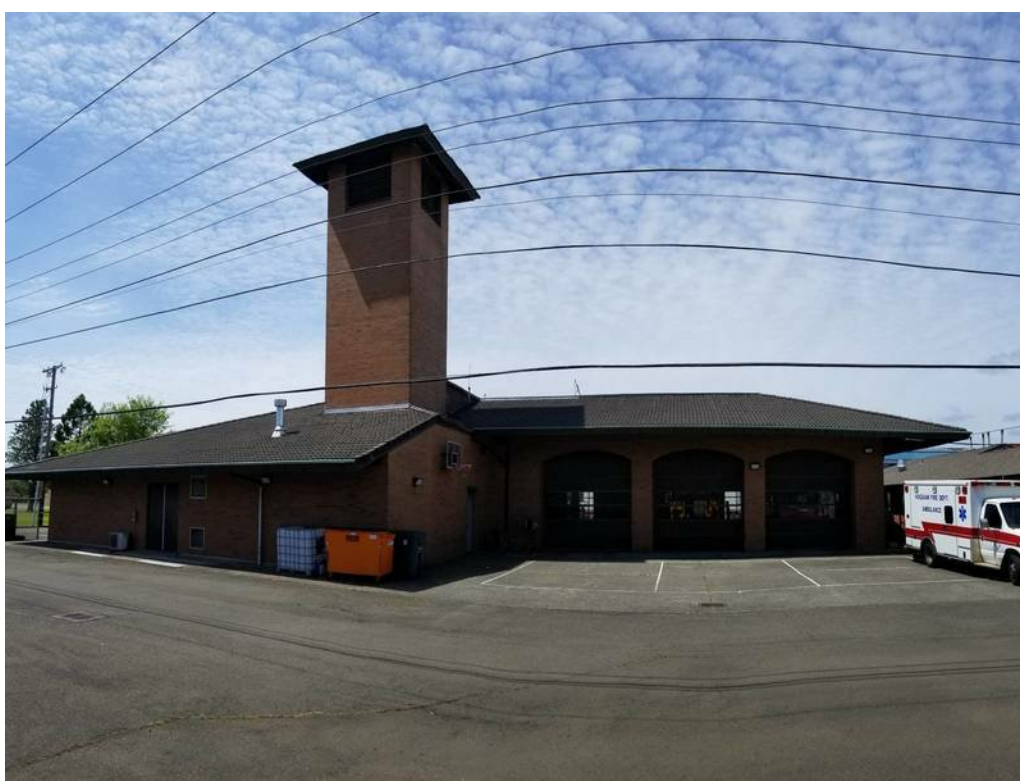
Figure 1-2. Southeast facade, which is the rear. Fire trucks can pull through the rear to allow them to face "forward" at the entrance.

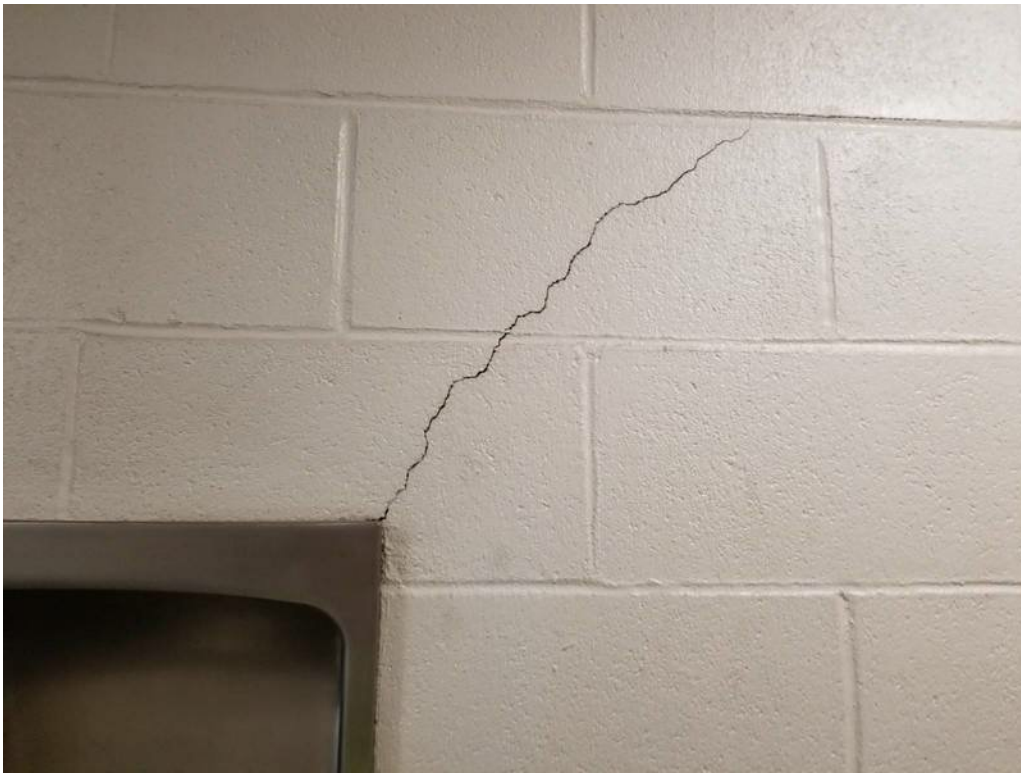
Lateral System	Fair. The CMU walls had shear cracks radiating from square openings at windows and doors in a few locations. It is unclear if this damage was caused by previous seismic activity, or by differential settlements, or both.
----------------	---

Figure 1-3. Typical view of a shear crack radiating from a door way.

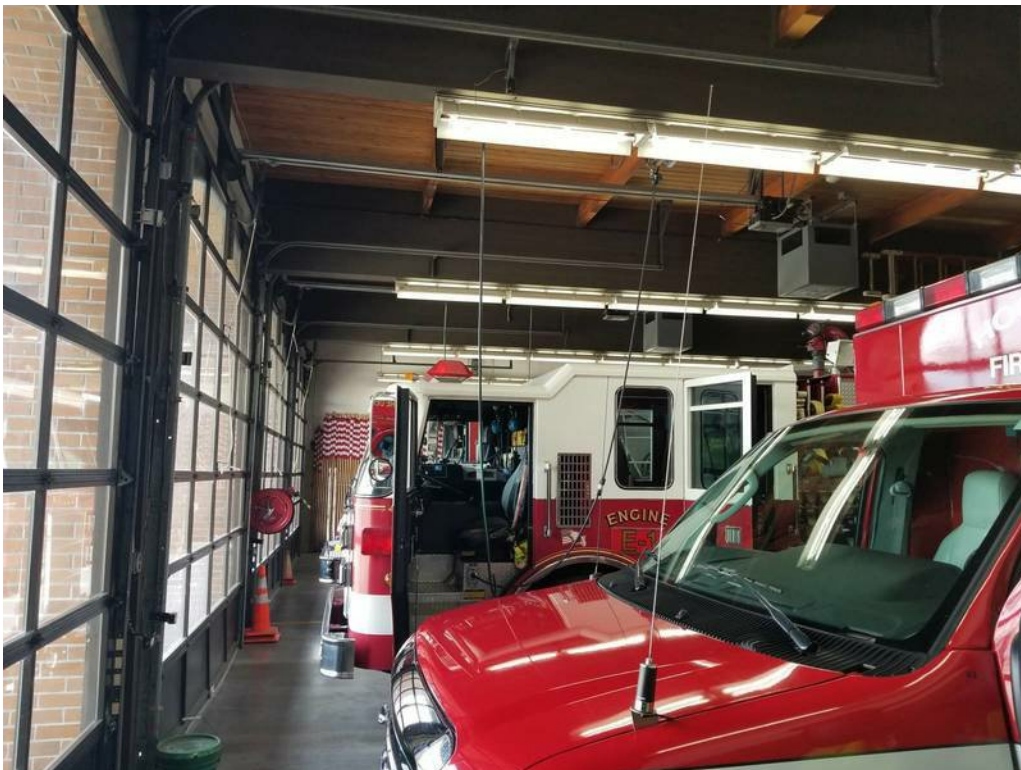
Figure 1-4. View at the front side of the garage bay.

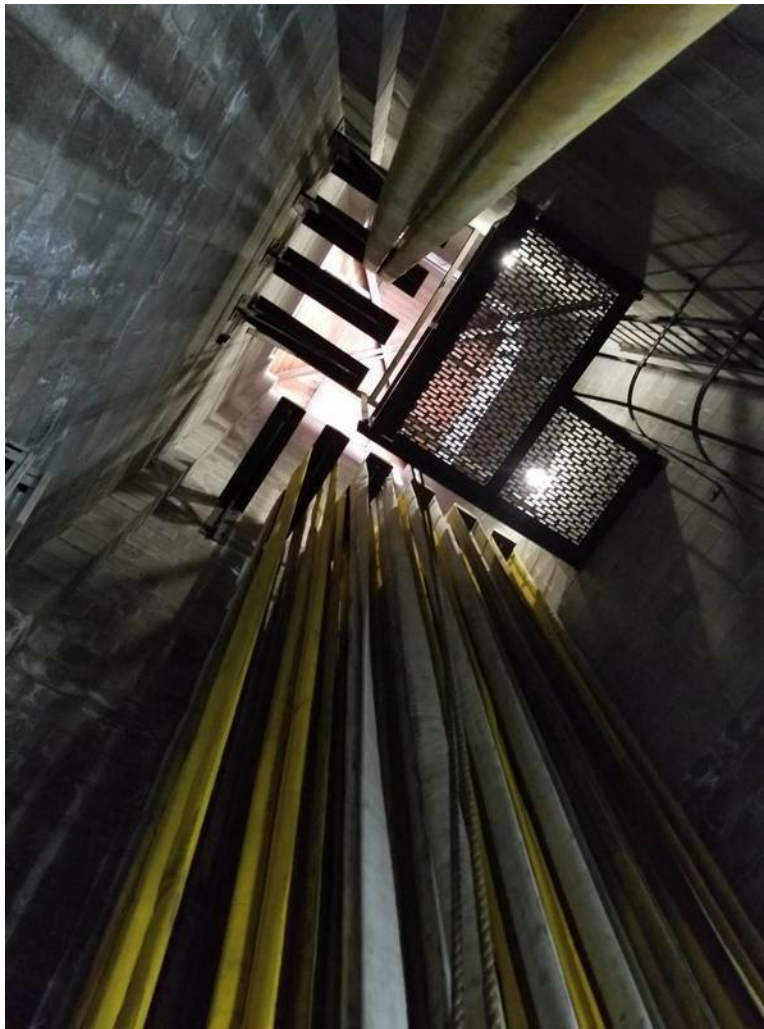
Figure 1-5. View of the hose tower from the base.

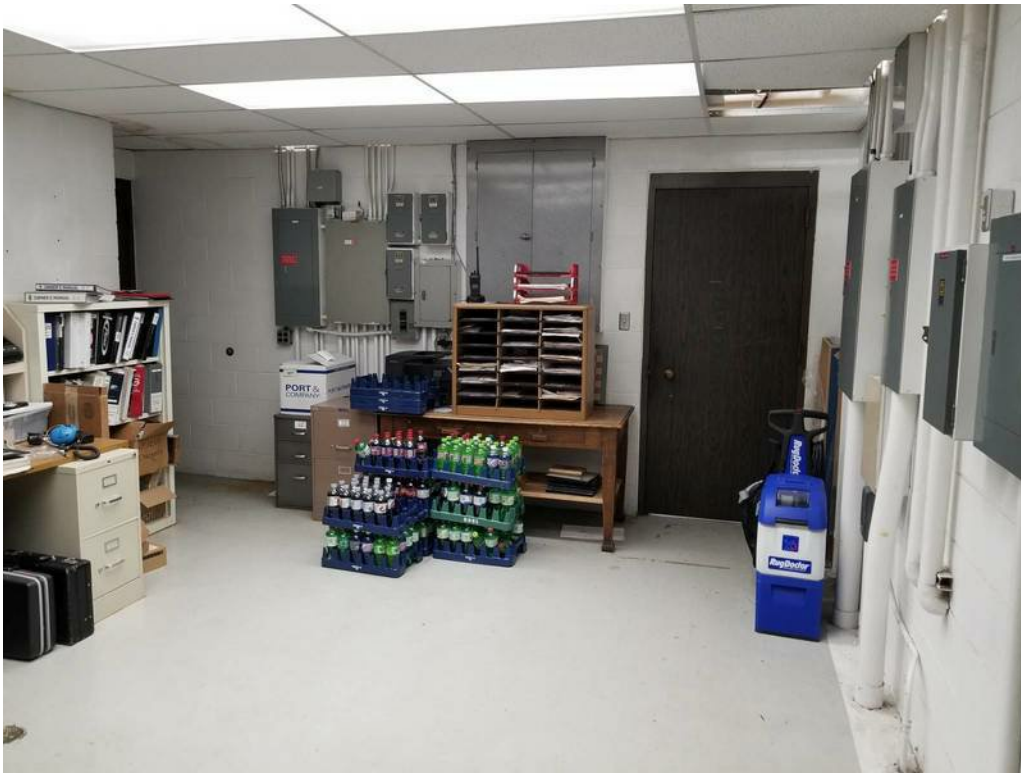
Figure 1-6. Data and storage room at first floor.

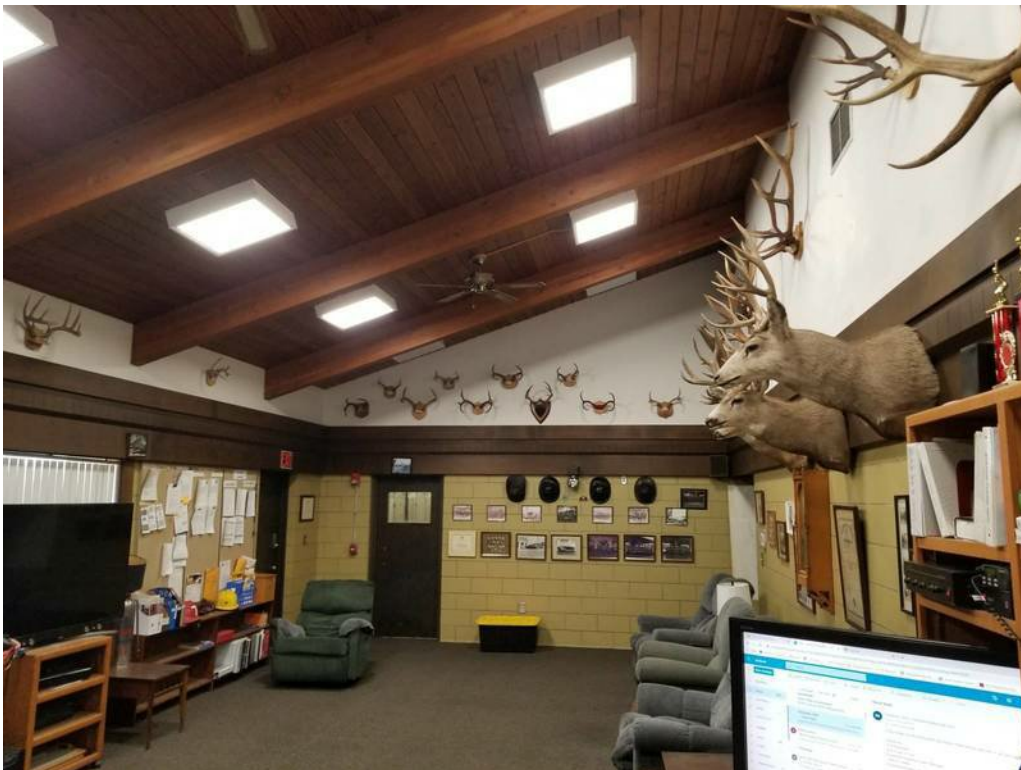
Figure 1-7. View of the lounge/operations area in the administrative wing.

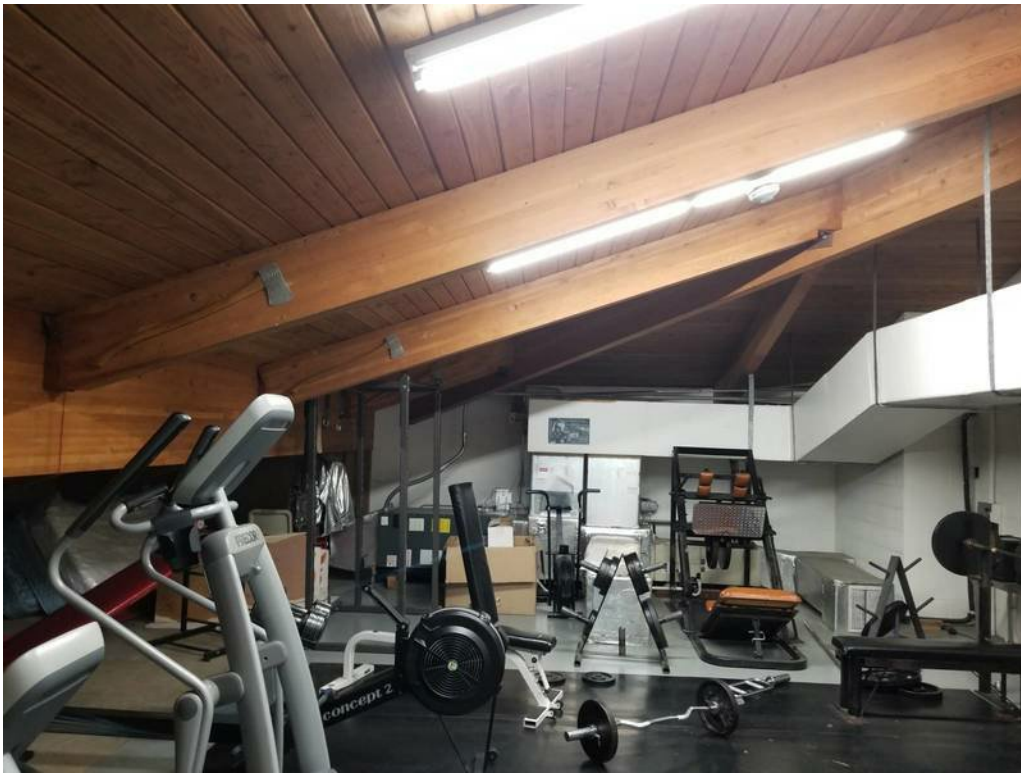
Figure 1-8. View of the weight training room at the second story "storage area".

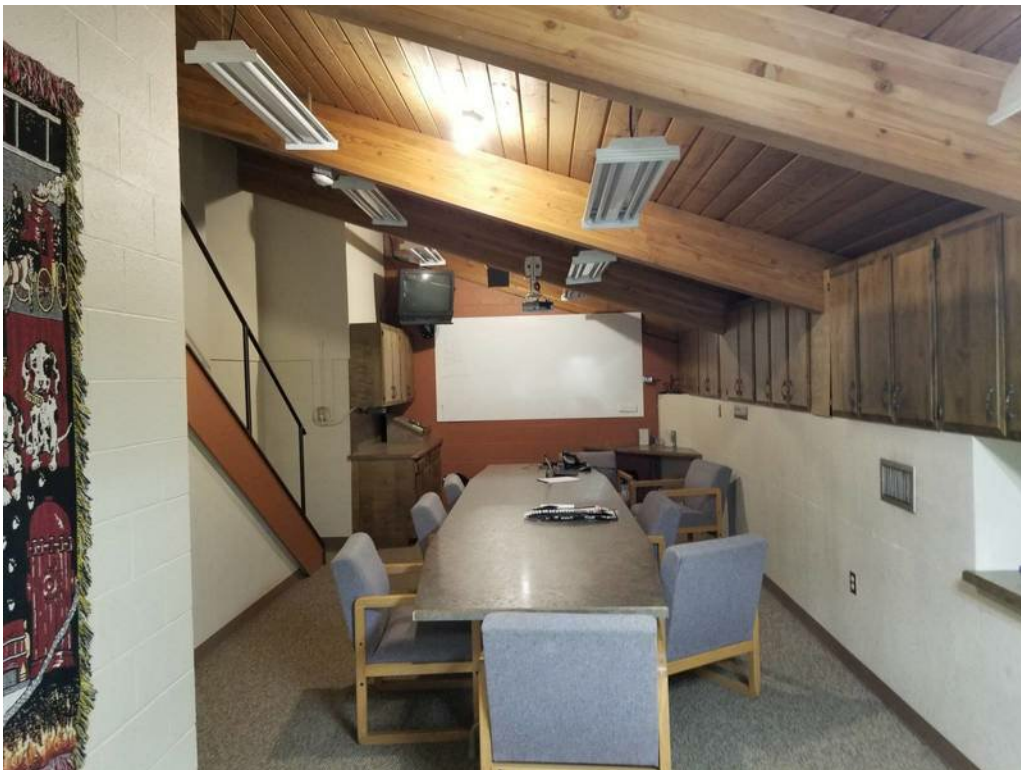
Figure 1-9. Conference space at the second story "storage area"

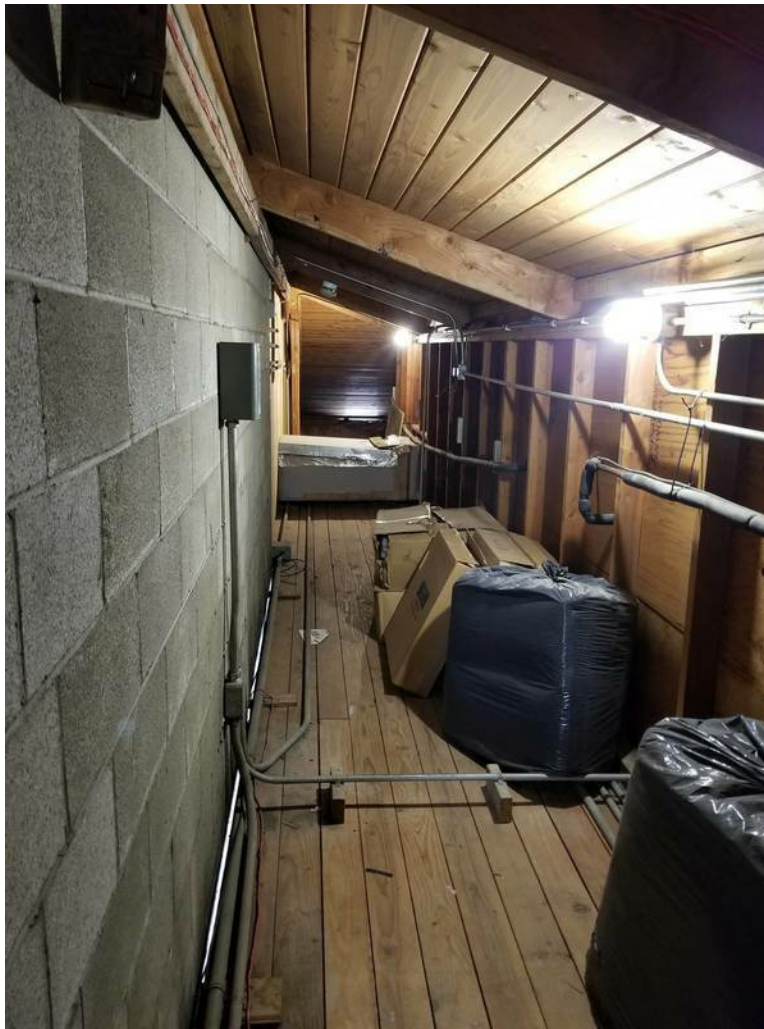
Figure 1-10. View of the second story storage area over the garage high-bay.
